INFOTECH R5 - 17-02

Sujet : Précaution d'assemblage transmission latérale/pivot

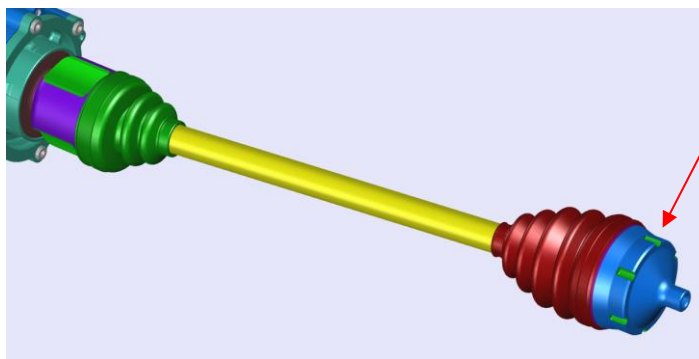
Encoche
(notch)

L'ajustement serré de cet assemblage peut en effet laisser penser que la transmission est correctement positionnée alors qu'elle ne porte en réalité pas sur toute la longueur du centreur.

The clearance between these two parts is so tight that sometimes you can think it is properly fitted whereas the pins are not fully supported.

Lors de chaque montage d'une transmission sur un pivot/porte-moyeu (et plus particulièrement quand ces pièces sont neuves), nous vous invitons à contrôler que l'extrémité de la transmission est bien complètement emmanchée sur les centreurs du moyeu.

When assembling a drive shaft on the upright (especially when new), please make sure the drive shaft is fully engaged on the pins of the upright.
